# Repairing the Fire Damaged Thakaneng Bridge at the University of the Free State, Bloemfontein, South Africa

*Craig Black<sup>1</sup>, and Johnnie Strydom<sup>2</sup>*

<sup>1</sup>WSP Africa, Johannesburg, South Africa

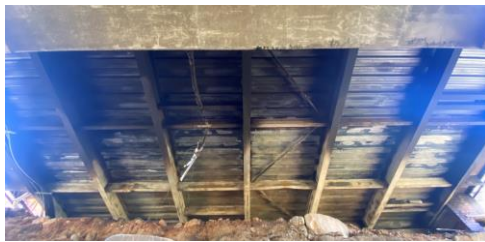
The western span (span 1) of the bridge experienced fire damage to the underside of the deck. The fire, which was seemingly caused by vagrants living under the bridge, extended to the building above resulting in further structural damage.

**Fig. 1.** Underside of Span 1

As part of the immediate actions, the client was advised to prop the underside of span 1 and close it off to the public until remedial works to the deck were complete.

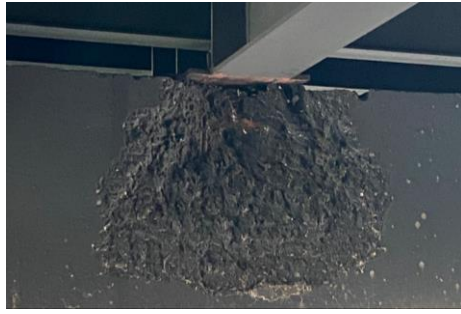
The heat transfer through the structural steel beams and into the holding down bolts had resulted in thermal expansion in the bolts causing spalling to the reinforced concrete piers. In addition, the permanent shutter decking below the unreinforced concrete deck, had separated from the concrete creating voids and unsupported areas to the bottom fibers of the concrete deck.

**Fig. 3.** Spalling at Top of Pier

A remedial works design was then conducted which comprised of removal and replacement of existing lateral members and diagonal bracing, installation of new longitudinal girders and installation of new lateral members to support the QC decking that had separated from the slab. The longitudinal members were placed below the permanent shutters, in-between the existing members and packer plates were used to ensure direct contact. Concrete repair was also conducted on all spalled concrete elements. The concrete was broken back, the reinforcement was primed with an epoxy zinc primer and a polymer modified fibre reinforced structural repair mortar was used to cover the reinforcement. Fencing was then installed around the abutments to prevent future access from vagrants.

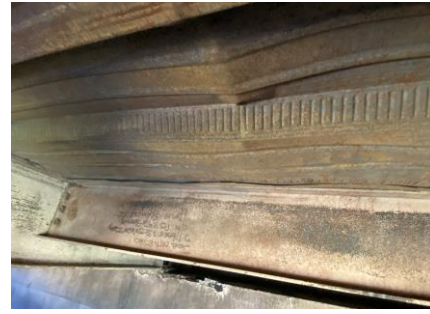
**Fig. 4.** Separation of Permanent Shutters

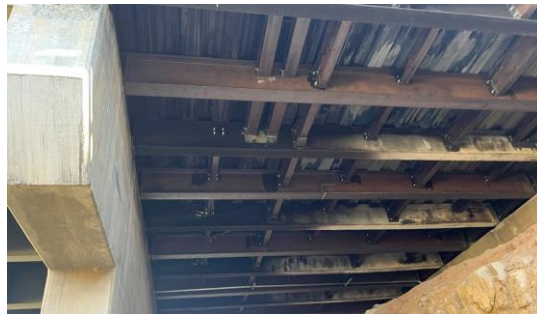
**Fig. 5.** Installation of New Structural Steel Members
