# Emergency Rehabilitation of Bridge N7 in Kerouane, Guinea

<sup>1</sup> WSP in Africa, Johannesburg, South Africa  
 johnnie.strydom@wsp.com

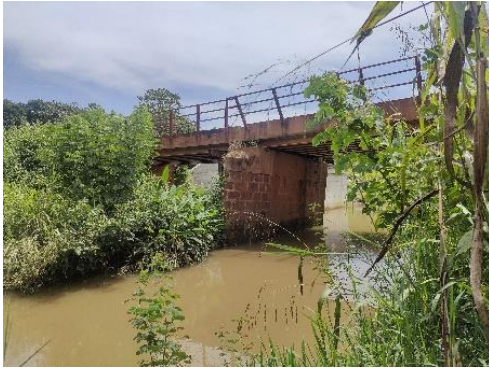
**Fig. 1.** Bridge N7 Elevation

| Component | Comment |
|---|---|
| Pier Walls | Pier is settling and failing in rotation resulting in only southern deck being supported. The northern deck is supported on temporary propping also showing signs of failure. |

Based on the visual inspection conducted in Phase 1 of the project, Bridge N7 was given an overall rating of 5 – UNSAFE due to settlement and rotation of the pier. It was deemed that the bridge should be taken out of service as a new one is being built upstream. The existing temporary support, by propping, was also failing. Figure 1 and Figure 2 below show the failing substructure.

As a temporary measure, the bridge is to be propped by the following steps:

1. Deviate river to span 1, excavate span 2
2. Construct base and install propping for span 2
3. Deviate river to span 2, excavate span 1
4. Construct base and install propping for span 2
5. Restore normal river flow under span 1 and span 2
